December 3, 2008

Subject: Literature Building Ceiling Tile

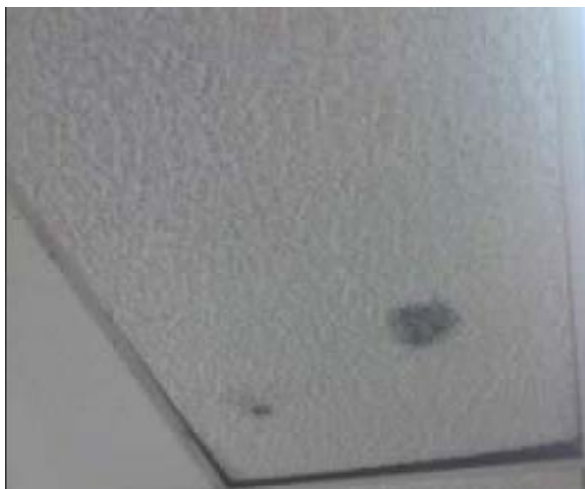
One ceiling tile in office 438 had two isolated patches of black mold growth visible from both the front and the back. The picture below is from the front of the ceiling tile. Both black mold patches were surrounded by water stains that had previously occurred.

The results show that there were some overlapping mycelia in the areas of growth on the ceiling tile. The mycelia are the vegetative part of a fungus, consisting of a mass of branching which is used to absorb nutrients from the environment. The tape sample is positive for *Stachybotrys* and *Penicillin/Aspergillus* spores and mycelia. Tape samples indicate the mold species, but do provide information on whether the mold is still actively growing. Because the ceiling tile was dry at the time of sampling and the mold patches were isolated, the mold growth is most likely desiccated and not actively growing.

Due to the overhead air conditioning units in many of the offices in the Literature Building, small leaks are to be expected. Please continue to contact Facilities Management Service Referral desk at x42930 or online at http://yamhill.ucsd.edu/APS_MntRequest/ewrequest.aspx to request immediate replacement of any ceiling tiles with signs of water leaks or mold growth. This will also allow Facilities Management to quickly address and prevent any further water intrusion or damage.
